**Yosemite NP
RIM Fire
2013
BURNED AREA
EMERGENCY RESPONSE PLAN**

**Yosemite National Park

Subject: Yosemite NP Rim Fire, Burned Area Emergency Response Plan

2013 Rim BAER

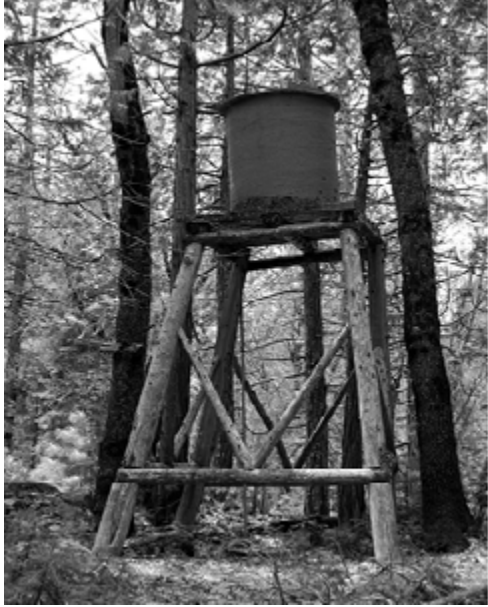
Most of the historic buildings and structures in Miguel Meadows have been confirmed lost. The only confirmed remaining structure is the non-historic pit toilet. Post-fire assessments are necessary to address any safety or hazardous materials issues associated with the fiberglass water tank, the homestead pit privy, and the cistern / well, and any other cultural resources that might remain in the location of the former barn, guard station, woodshed and storage building. No clean-up or treatment activities are specified at this time. However, any recommendations made after the assessment will be designed to avoid affecting remaining attributes of the cultural resource (including archeological ruins).

Figure 2. (right) Miguel Meadow Fire Guard Station

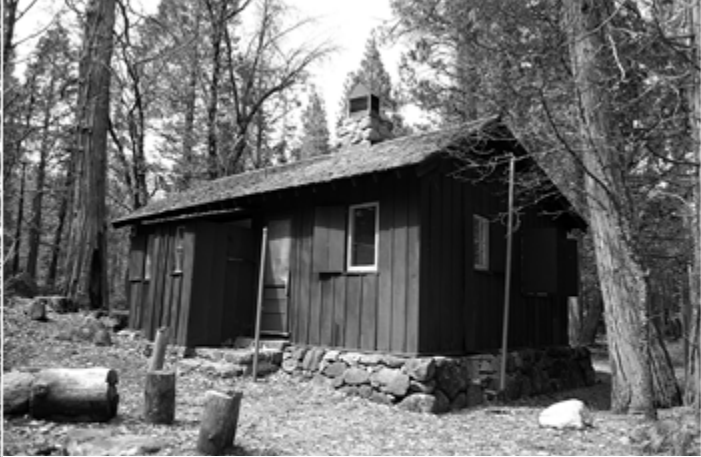
Figure 3. (left) Water tank at Miguel Meadow

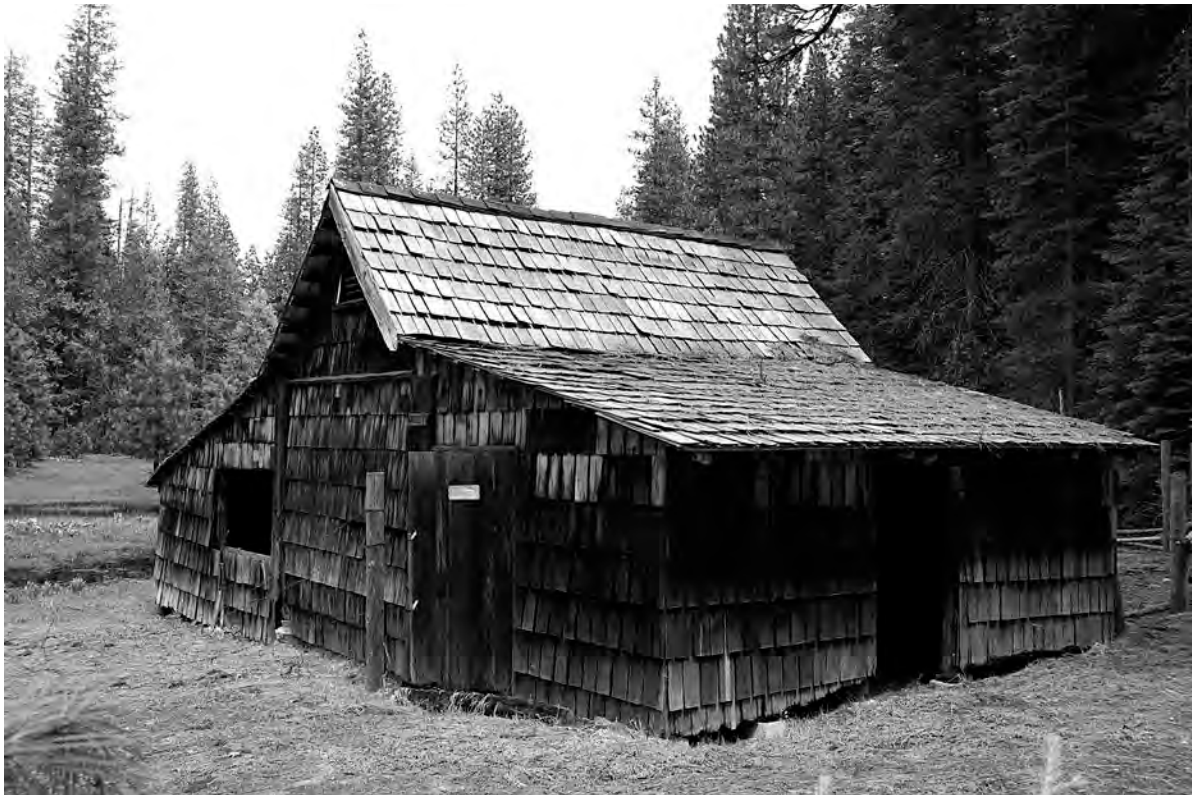
Figure 4, Miguel Meadow Barn

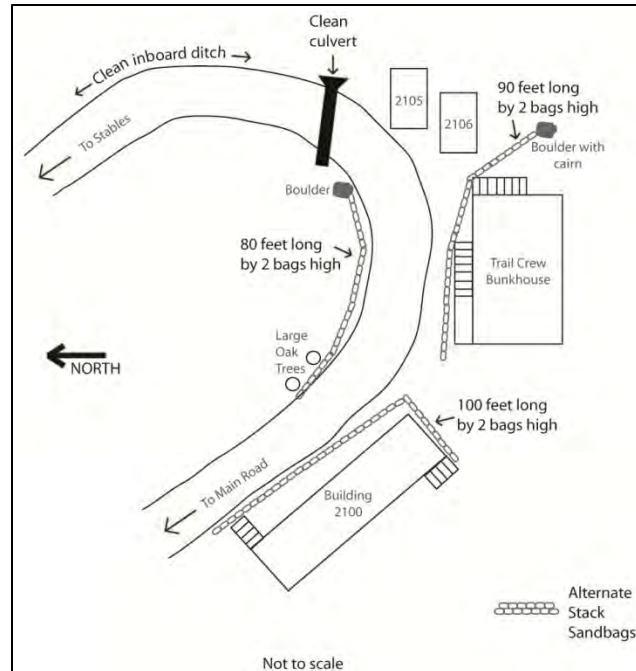
Hetch Hetchy Housing: The Hetch Hetchy housing area has six buildings, two tent cabins, and a road that leads to a corral. Two cabins and the tent cabins are built in a poor location relative to the small stream that discharges between structures 2106 (tent cabin) and the trail crew bunkhouse (Figure 1) and then between the bunkhouse and building 2100. A cross-drain culvert drains the road to the corral onto an open area which drains down the corral road past building 2100.

Figure 1. Diagram of Hetch Hetchy cabin area at risk to nuisance flooding.

The only structures at risk to post-fire watershed conditions in this area are the trail crew bunkhouse and building 2100. The watershed above this area shows mostly low to unburned soil burn severity. The vegetation canopy is mostly intact and the small stream still has high complexity due to unburned vegetation and exposed rock and boulders. Post-fire watershed conditions pose a limited threat to two cabins in the area from nuisance flooding. A sandbag treatment is recommended to protect the bunkhouse and building 2100. The tent cabins (building 2105 & 2106) are elevated above ground surface and not at risk.

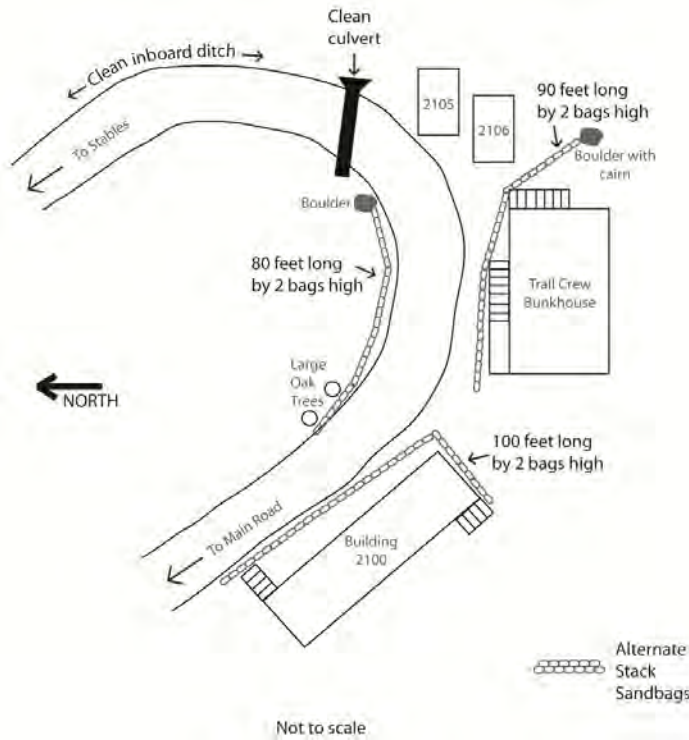
- D. Purpose of Treatment Specifications (relate to damage/change caused by fire):** Upstream post-fire watershed conditions may cause flooding which may damage buildings; placement of sandbags may reduce the risk.
- E. Treatment consistent with Agency Land Management Plan (identify which plan):**
- F. Treatment Effectiveness Monitoring Proposed:** Monitor sandbag condition after storms and replace as needed. Remove sandbags after three years.

- A. General Description:** Place sandbags at site to protect structures from post-fire watershed flooding. Use weed free sand to fill sandbags. When filling the sandbags, never overfill; only fill 2/3 of the way and seal. Extra sandbags are provided for maintenance.

- B. Location/(Suitable) Sites:** Hetch Hetchy cabins.
- C. Design/Construction Specifications:**
Hetch Hetchy Cabins: Refer to below illustration. Install three rows of sandbags, one 90 feet long stacked two high along the Trail Crew Bunkhouse, one 80 feet long stacked two high along stables road making sure the small ditch is captured by the sandbags, and one 100 feet long row stacked 2 bags high along building 2100. Stack sandbags as if building a brick wall by alternating placement. Approximately 720 sandbags will be needed at this site. Use burlap or other non-solar degradable bags. Consult with the cultural resource staff on sandbag color.
